ALERT SERVICE BULLETIN

REPLACEMENT OF FUEL PUMP

FOR ROTAX® ENGINE TYPE 912 (SERIES) SB-912-053

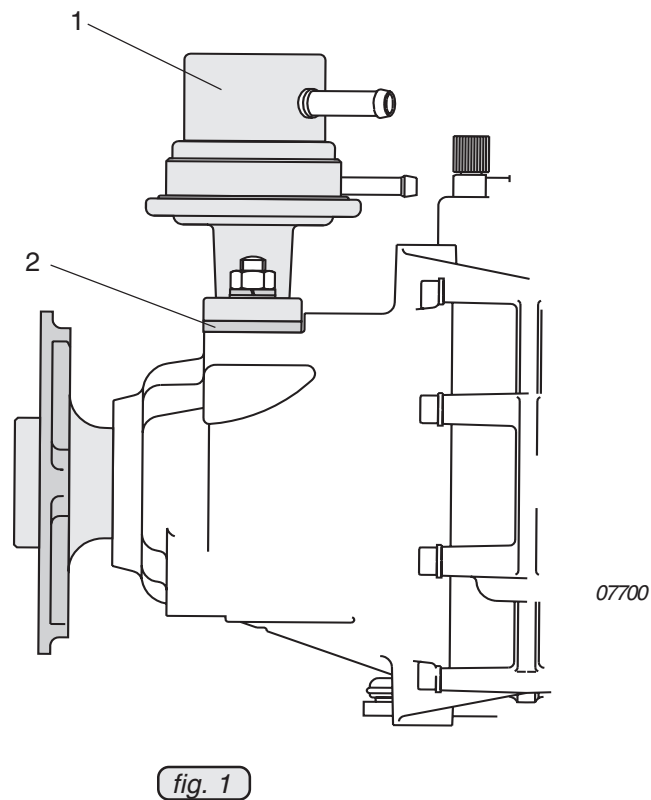
Due to high fuel pressure, caused by exceeding pressure in front of the mechanical fuel pump (e.g. due to an electrical fuel pump), in limited cases a deviation in the fuel supply could occur. This can result in exceeding of the fuel pressure and might cause engine malfunction and/or massive fuel leakage.

1. Remove fuel pump (1).
2. Gasket (2) replaced by new part.

■ **CAUTION:** Install new gasket supplied with new fuel pump. The thickness is different.

3. Install fuel pump. Tightening torque 15 Nm (133 in.lb).
4. Install fuel line.
