# ALERT SERVICE BULLETIN

## CHECKING OF MAGNETIC PLUG ON ROTAX® ENGINE TYPE 912/914 (SERIES)

ASB-912-051UL

ASB-914-034UL

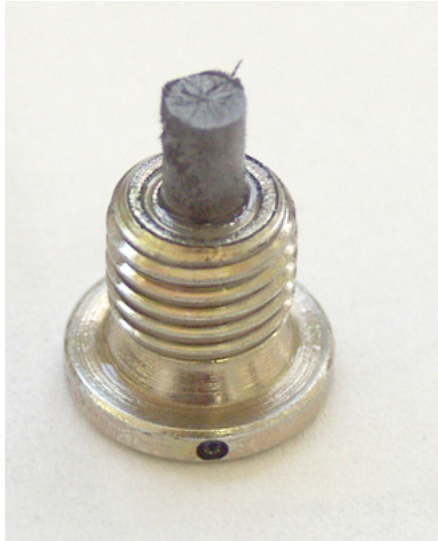
fig. 1

acceptable

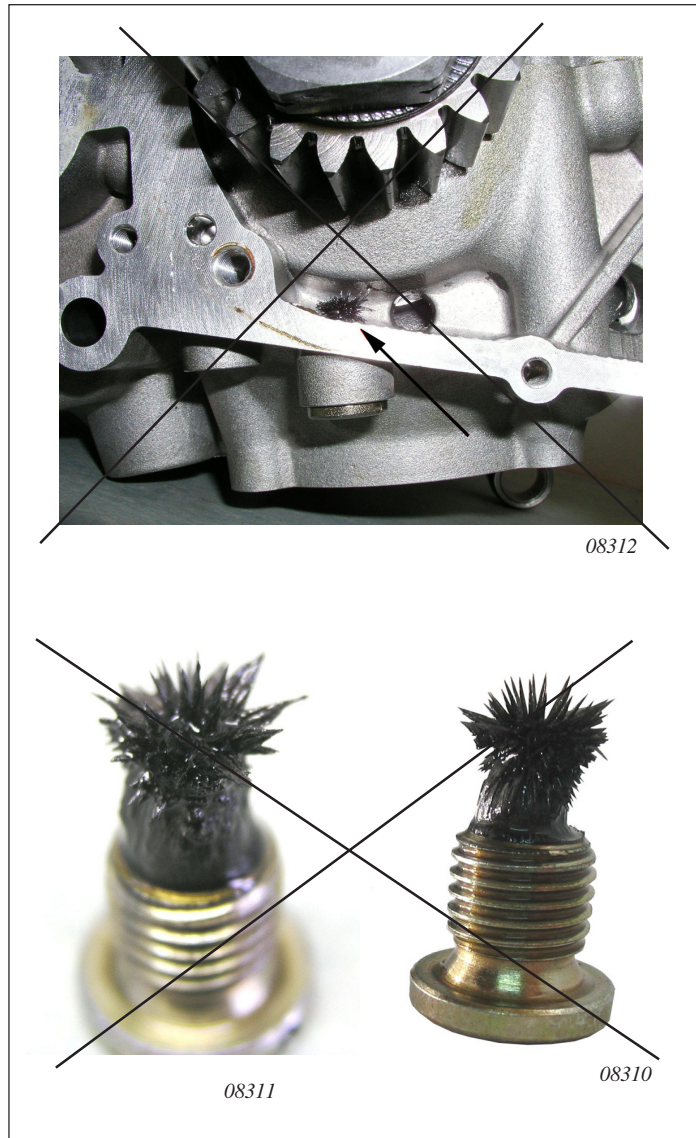
fig. 2

■ **CAUTION:** If a greater quantity of metal particles (more than 3 mm (1/8")) is detected, consultation of an authorized distributor regarding further action is necessary. The engine must not be taken into operation until the cause has been identified and eliminated.

not acceptable
