SERVICE BULLETIN

Periodic inspection of the float buoyancy for ROTAX® Engine Type 912 and 914 (Series)

ATA System: 73-00-00 Fuel system

MANDATORY

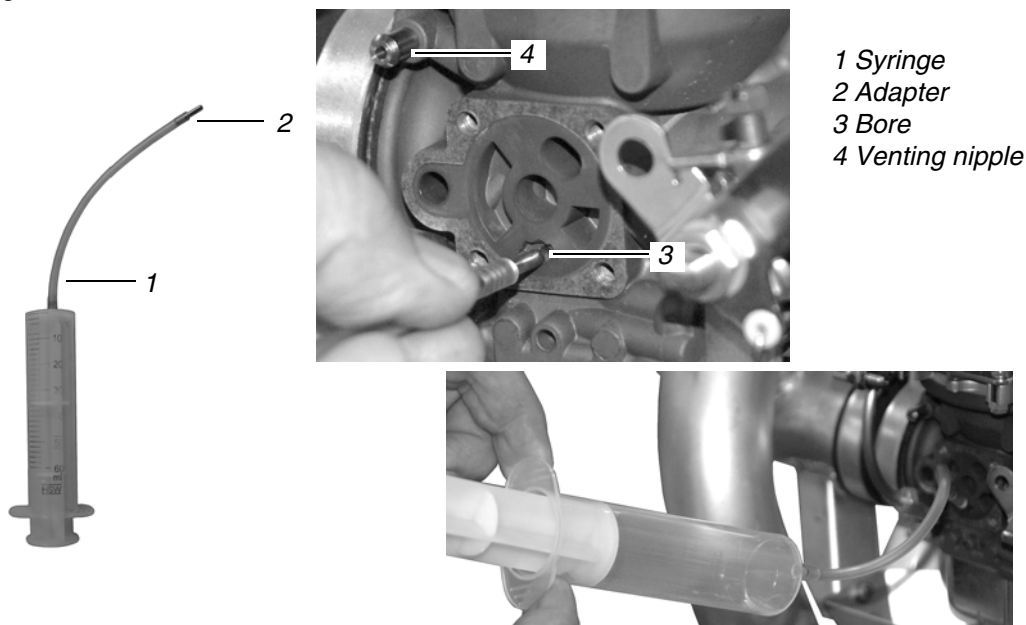
Fig. 2

Step	Procedure
1	Fill the syringe (1) with 40-50 ml amount of fuel.
2	Connect syringe with the adapter (2) using a transparent fuel hose
3	Fuel hose and adapter must be free from air bubbles.
4	Insert the adapter (2) in the lower bore (3) of the rotary valve. Ensure a firm fit.

NOTE: During the following inspection of the volume, carefully fill the float chamber with a syringe until the fuel leaks from the venting nipple (4). This process should take about 5 seconds. Record capacity before the filling operation. The capacity can be determined by reading the scale of the syringe.

Step	Procedure
5	Fill the float chamber until the fuel leaks from the venting nipple.
6	Determine the volume.
7	Perform the same inspection on the second carburetor.
8	The results of the measurement must be documented in the maintenance records.

Filling volume in float chamber	Evaluation
23 ml - 40 ml	Floaters are OK, the float level is within the limit.
less than 23 ml	Significant deviation of the float levels. A detailed inspection of the floaters or their weight is necessary. See section. 3.5).
more than 40 ml	Significant deviation of the float levels. Repeat inspection to avoid incorrect measurements. See section 3.1.1). A detailed inspection of the carburetor and floaters or their weight is necessary. See section. 3.5). Check float needle valve for any leakage and setting of the float bracket.

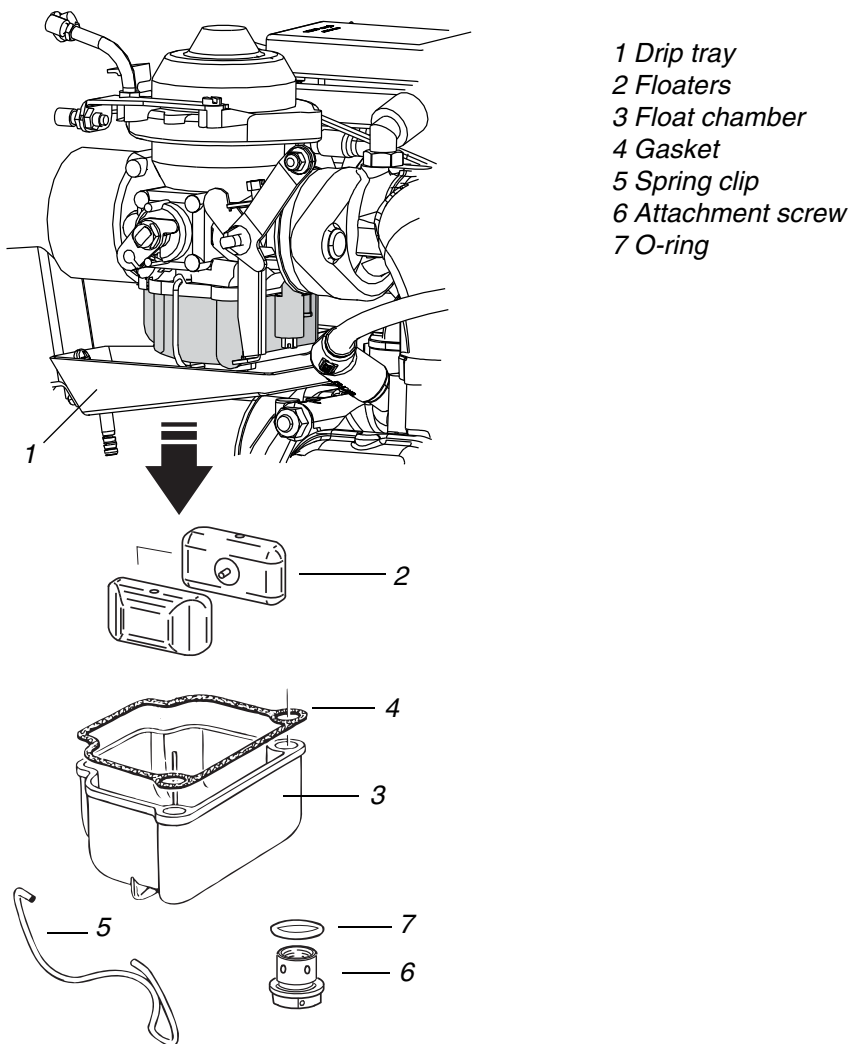
Fig. 4

Step	Procedure
1	Remove drip tray (1).
2	Visual inspection of the carburetor and its mechanical actuation.
3	Remove spring clip (5) and for ROTAX 914 Series loosen cap screw (6) and remove with O-ring (7).
4	Remove float chamber (3), gasket (4) and the two floaters (2)

Step	Procedure
1	Let the floaters dry for 1-2 minutes. Only balance dry floaters.
2	Check the weight of all affected floaters using a calibrated balance (1). Measuring tolerance of the balance: max. 0.1 grams.
3	The results of the measurement must be documented in the maintenance records. The max. allowable weight (of both floaters) is 7 grams.

Renew all floaters which exceed the max. weight.

Step	Procedure
1	Remove the gasket (4) from the float chamber and for ROTAX 914 Series remove the O-ring (7).
2	Install float chamber (3) with gasket (4) and the both floaters (2).
3	Close spring clip (5) or for ROTAX 914 Series install the attachment screw (6) including O-Ring (7). Tightening torque of attachment screw 5.5 Nm (48.7 in.lb).
4	Install drip tray (1).
