SERVICE BULLETIN

Periodic inspection of the float buoyancy for ROTAX® Engine Type 912 and 914 (Series)

ATA System: 73-00-00 Fuel system

MANDATORY

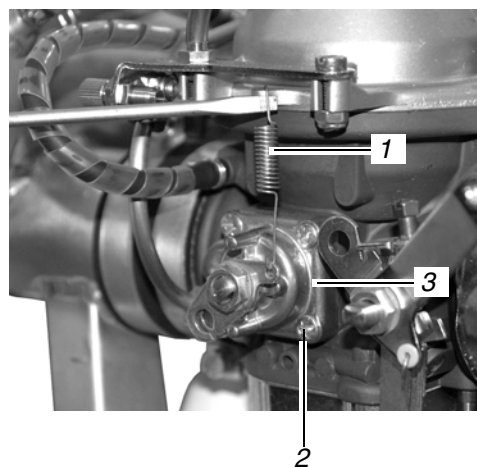
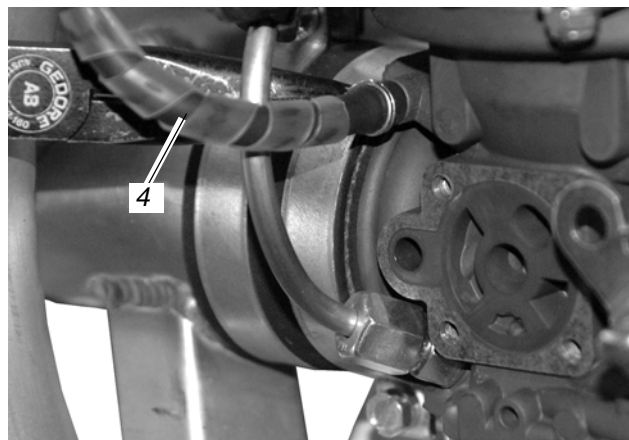
Fig. 1

- 1 Return spring
- 2 Philips head screw M4x14
- 3 Rotary valve housing
- 4 Air vent line

Step	Procedure
1	Bring the float chamber to horizontal position (level the aircraft, if necessary).
2	Let the engine idle for approx. 1-2 minutes. NOTE: Switch OFF the electric fuel pump (at 912 Series).
3	Remove the return spring (1).
4	Remove 4 Philips head screws (2). Remove rotary valve housing (3) with the gasket.
5	Remove the air vent line (4). Installed steel line must not be removed.

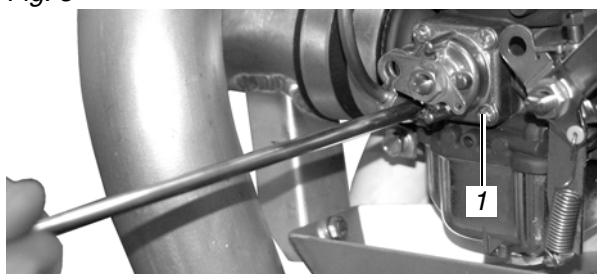
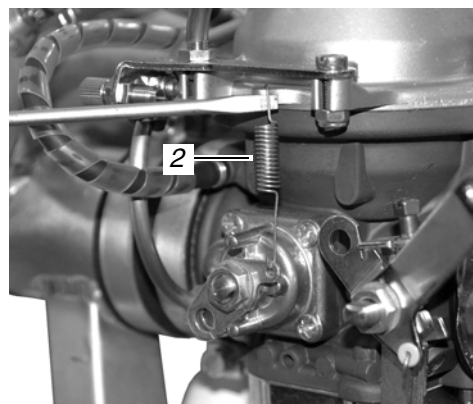
Fig. 3

1 Philips head screw 4x14
 2 Return spring

Step	Procedure
1	Install the venting line.
2	Install rotary valve with new gasket.
3	Secure first 2 threads of the Philips head screw 4x14 (1) with LOCTITE 243.
4	Install the return spring (2).
